● Energy Saving Case Study

KENS.CO, JAPAN

Warehouse of garment manufacture

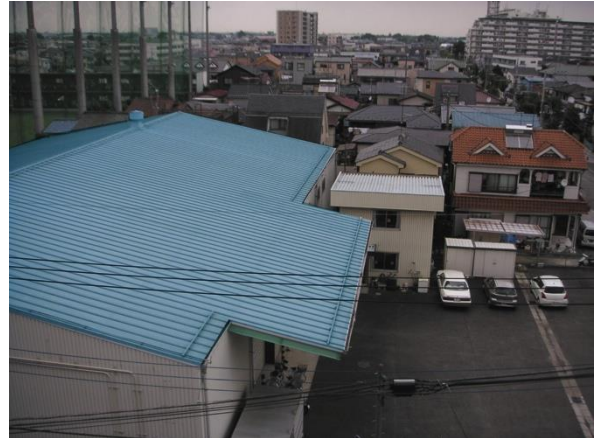
Painted part on the roof

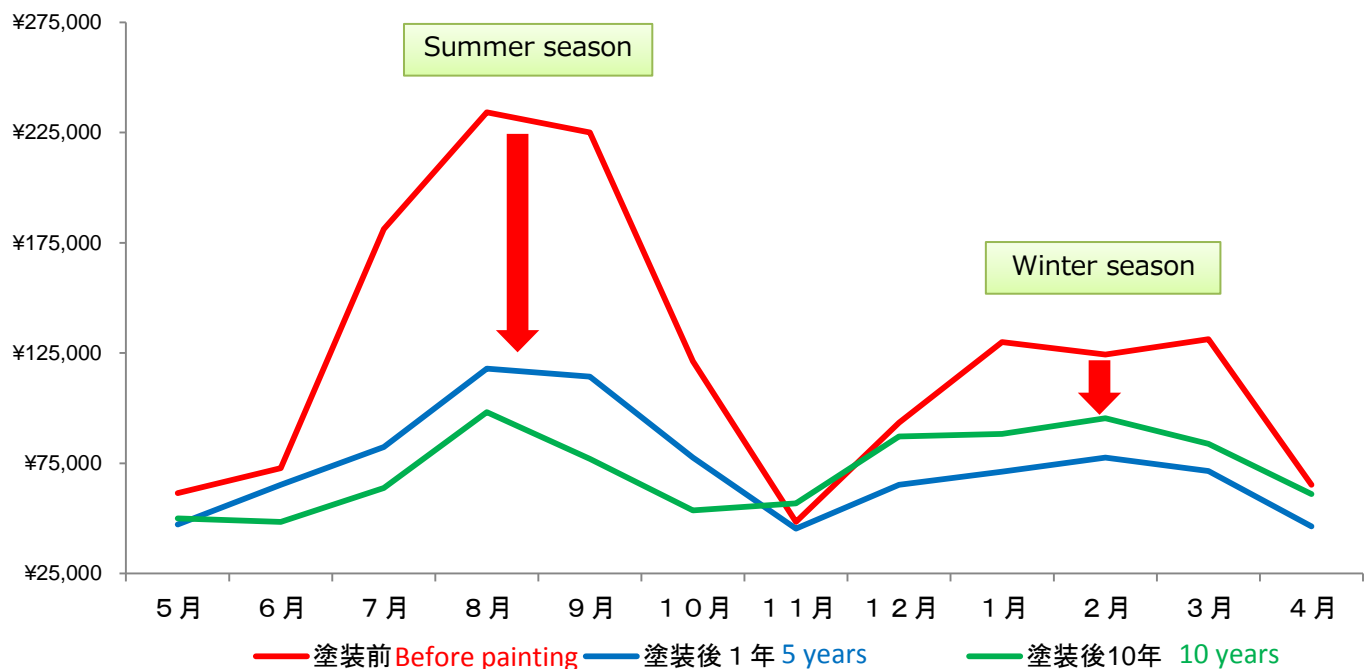
- 8.2 million YEN reduction in 10 years
- 15°C reduction in 2nd floor, 4 to 1 air conditioner.
- no water sprinkling in summer
- Energy efficiency in winter was enhanced
- Lengthening of painting cycle

● Power consumption data (comparison of painted and no-painted period)

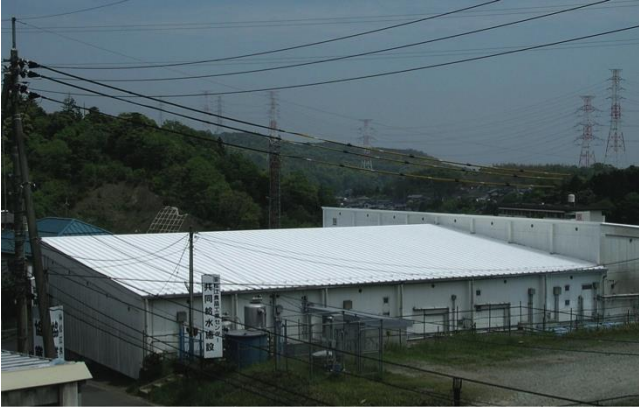
Painted part on the roof

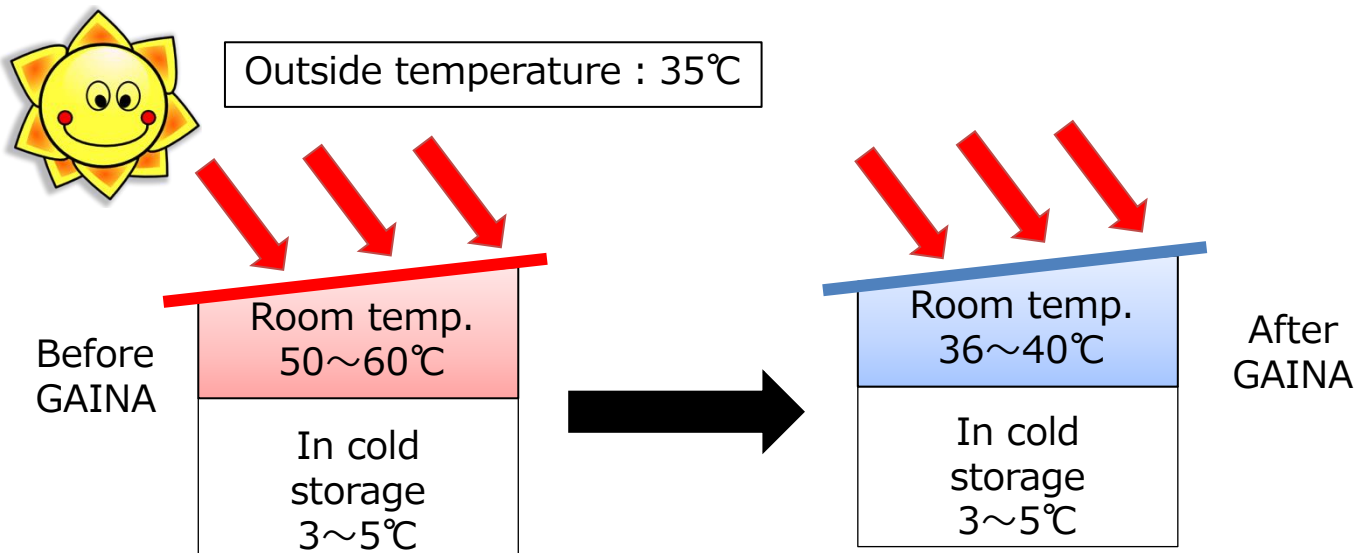
● Effects after peak cut

- 7.4 million Yen cost cut in two years
- Awarded by the Director of Resource Energy Agency of Japanese government in 2005.

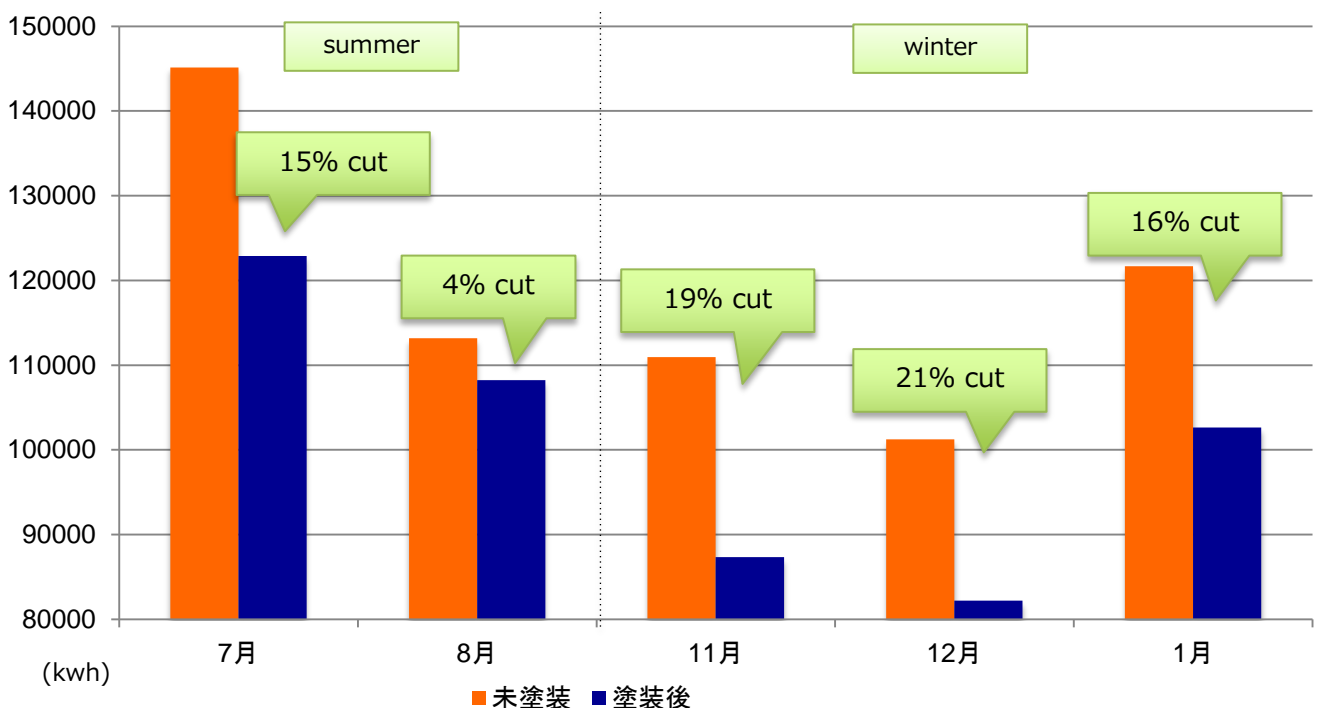
- Temperature of the back of ceiling was reduced 20℃ in summer.
- Efficiency of air conditioner was increased in summer and winter.
- 1.4 million Yen was cut in a year.

● Power consumption graph in summer and winter

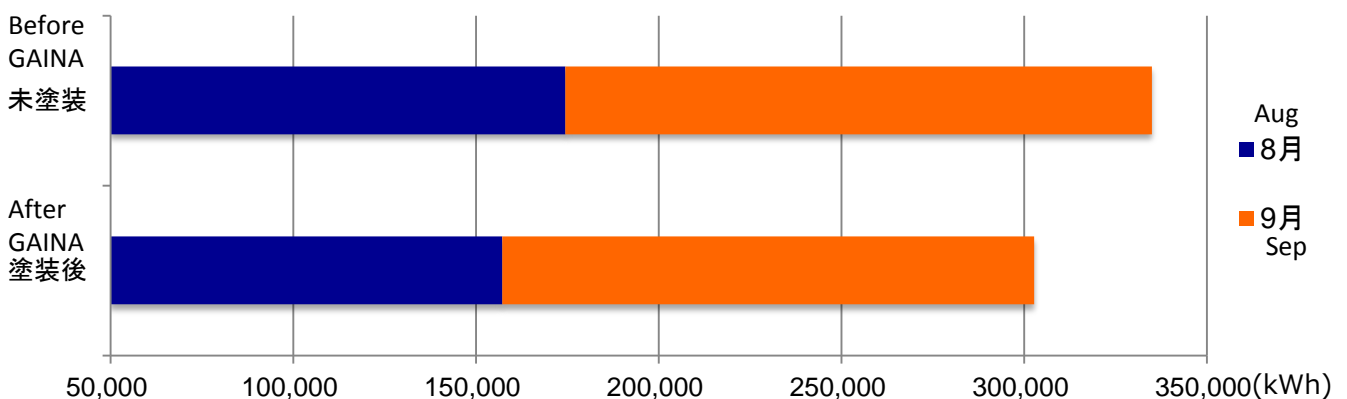
- 10% power consumption reduction in August and September
- 1.08 million yen cut in summer four months. (1kWh=17Yen)

● Comparison of power consumption

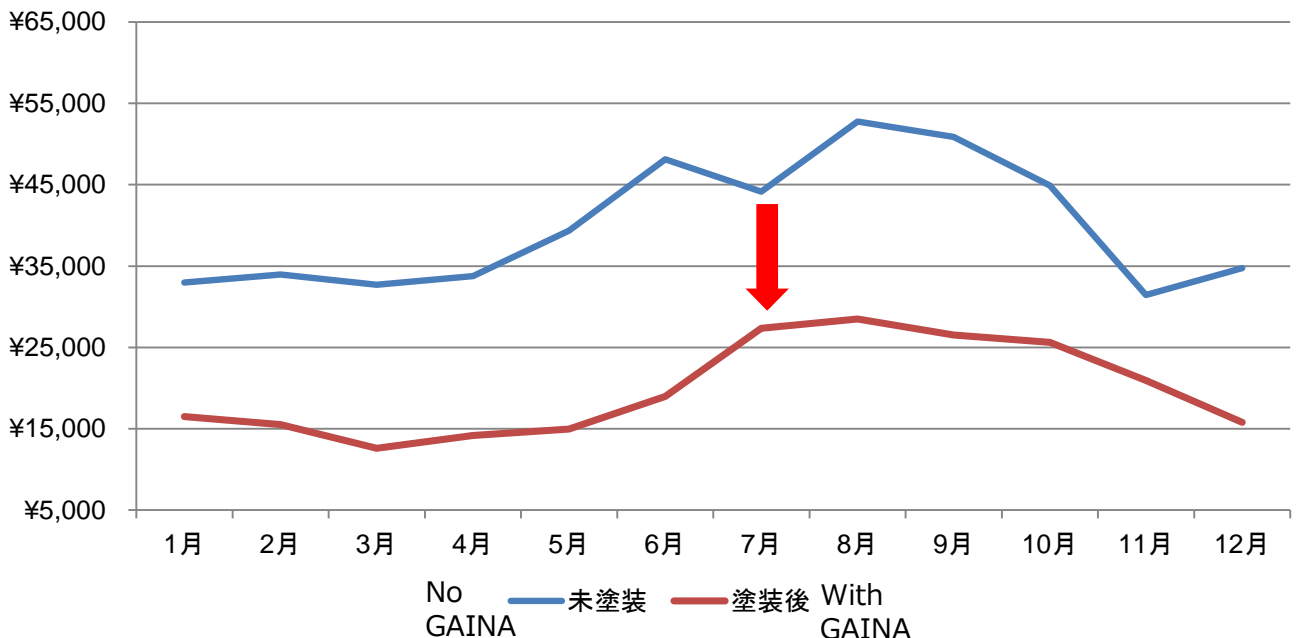
- before painting 0.47 million Yen, After painting 0.24 million Yen (50% cut)
- stop using heater in winter season

● power consumption graph

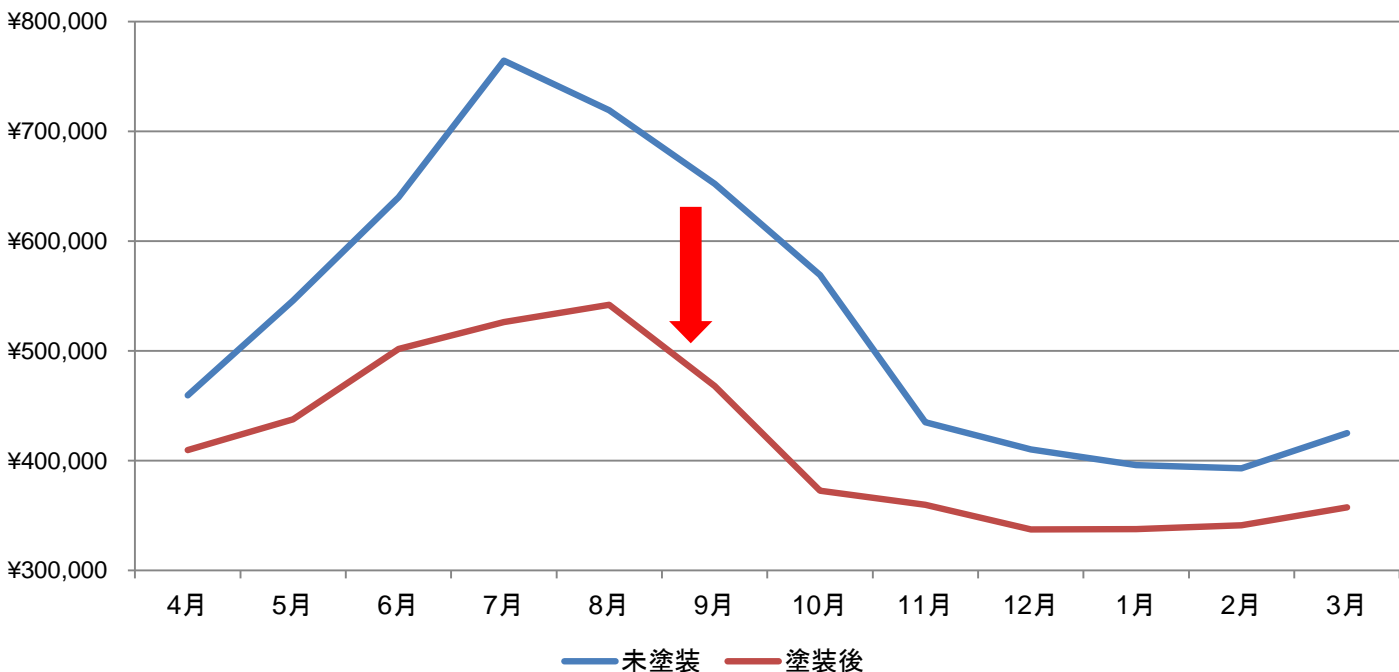
- 1.41 million Yen cut in a year
- Penetrating cold in winter was reduced.

● power consumption graph

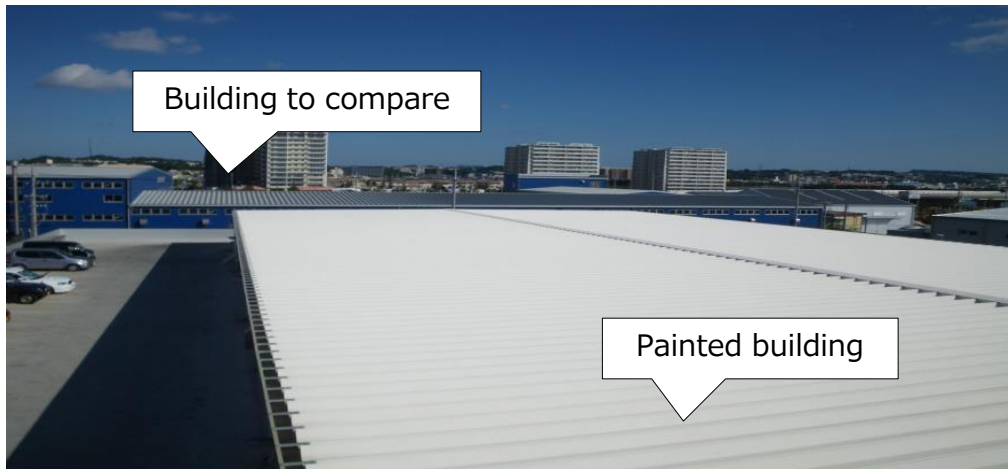
Tested inside temperature of two buildings (photo above) under the same condition. Temperature of the backside of roof was reduced at maximum 8.9℃, average 5.3℃.

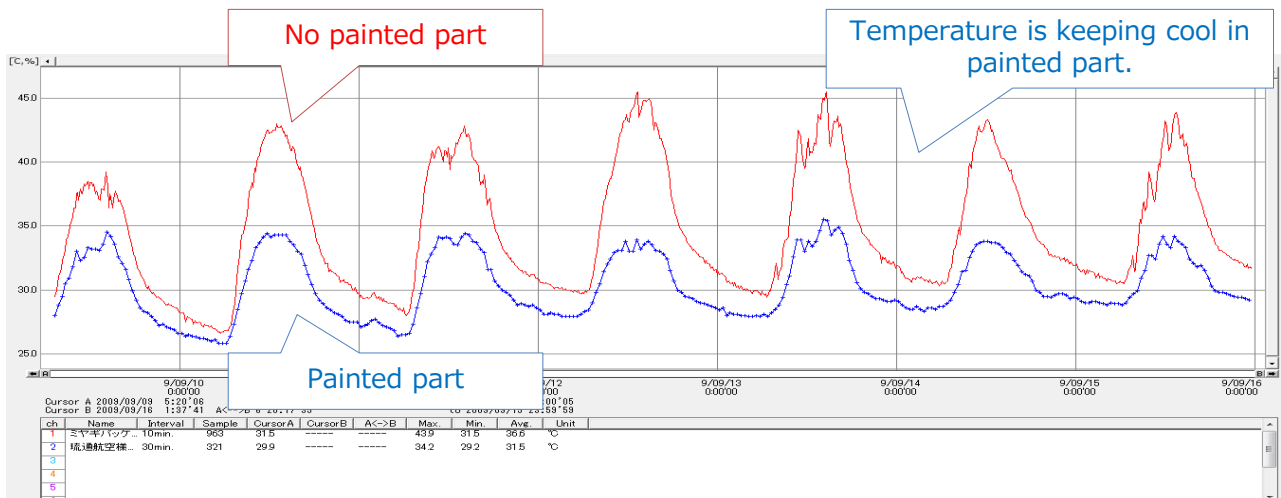
figure	Temperature of the backside of roof	
	Average	Maximum
Not painted	36.7℃	43.3℃
painted	31.4℃	34.4℃
reduction	−5.3℃	−8.9℃

※Max temp : 33.0℃,
Average temp : 29.6℃

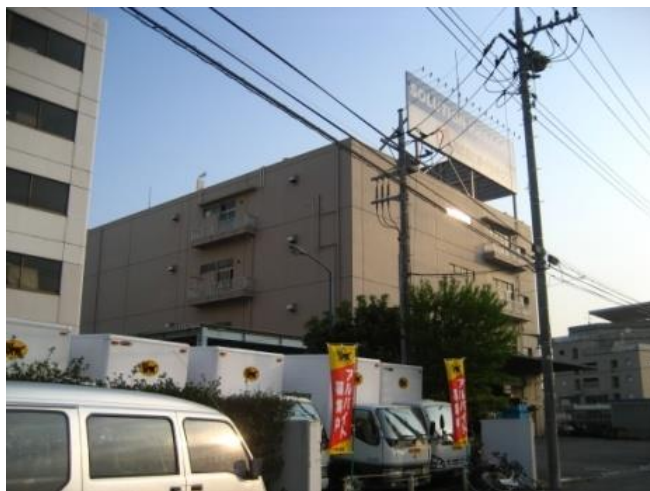
Painted part

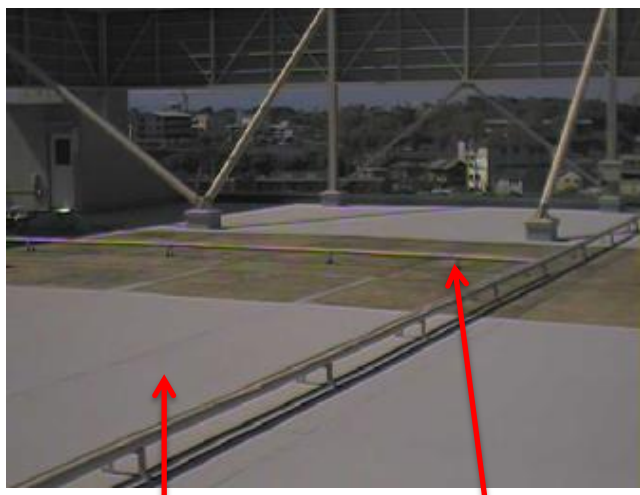
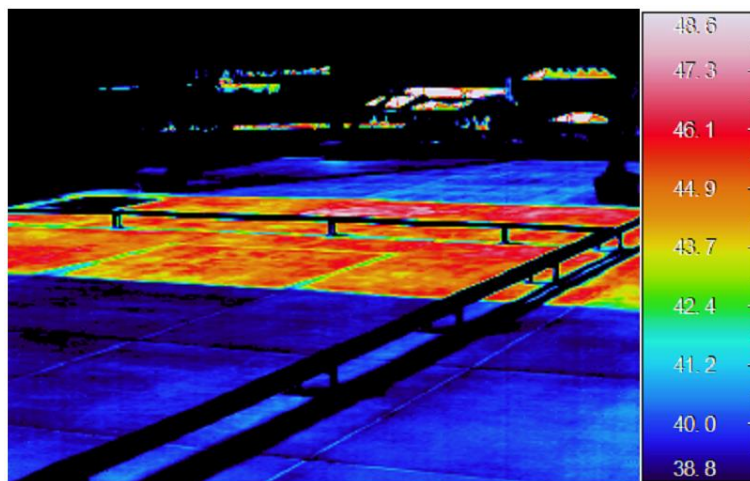
Thermography

No painted side	Painted side
Concrete	44 ~ 48℃	35 ~ 40℃

painted

Not painted

※Date : Sep 2008 13:00pm
Temperature : 33℃

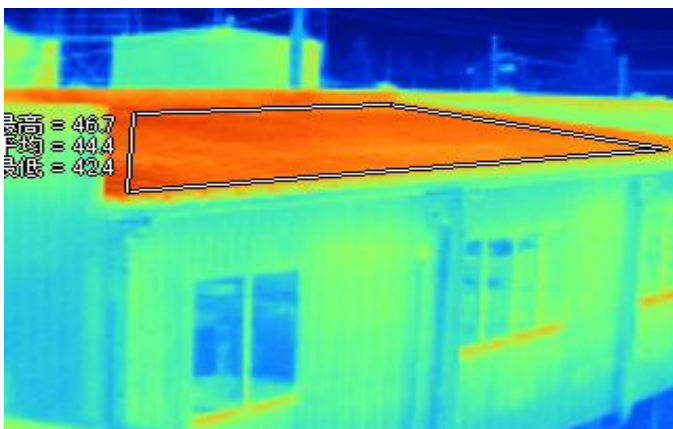
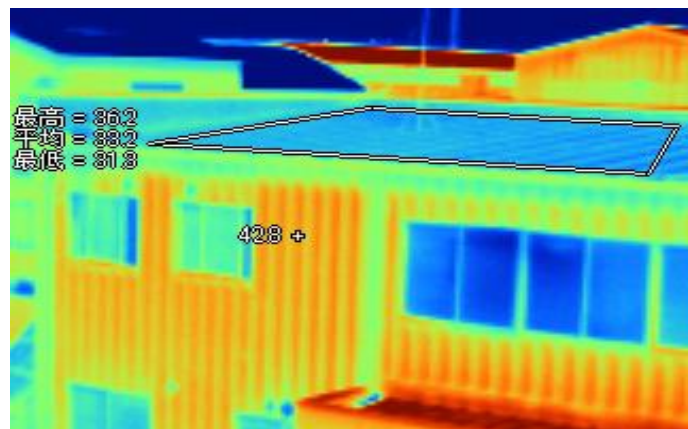
No painted side	Painted side
Surface	44°C	33°C
Back of roof	41.5°C	33.5°C

Before painting

After painting

※Date : Sep 2009 13:00pm
Temperature : 33°C

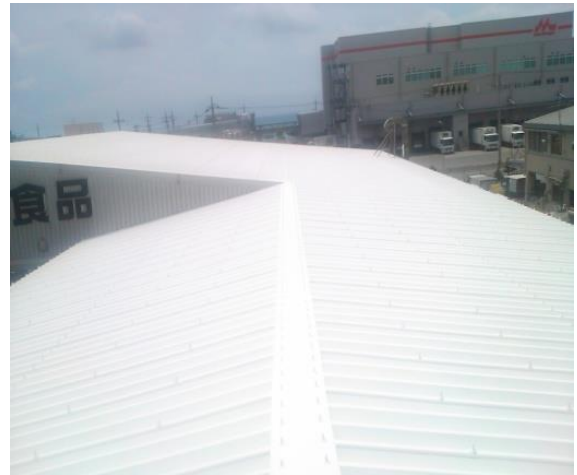
Painted part

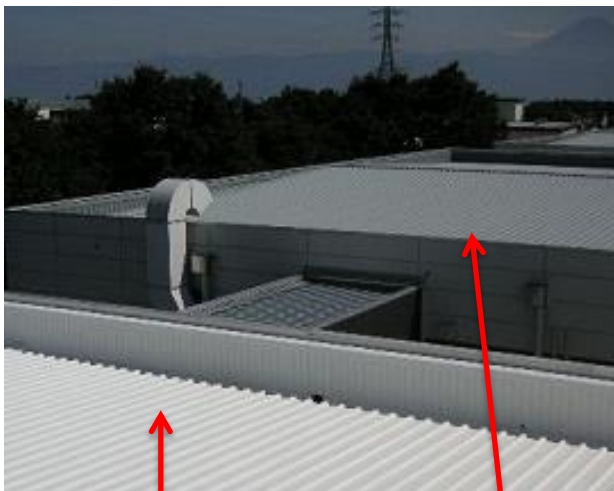
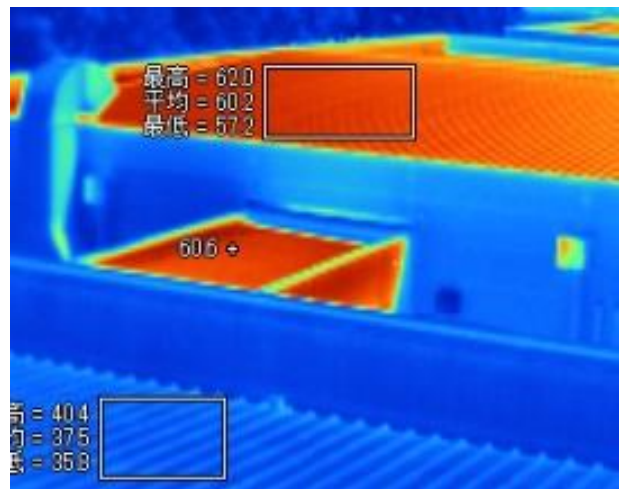
thermography

No painted side	Painted side
Folded plate roof	57 ~ 62℃	35 ~ 40℃

painted

Not painted

※date : Sep 2010 13:00pm
Temperature : 33℃

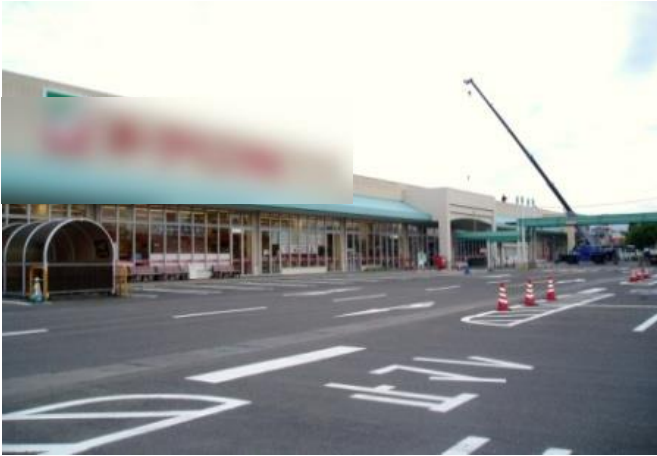
Structure of roof :

- Galvalume plate roof
- Air layer 1000mm
- Glass wool 100mm
- Gyptone 9.5mm

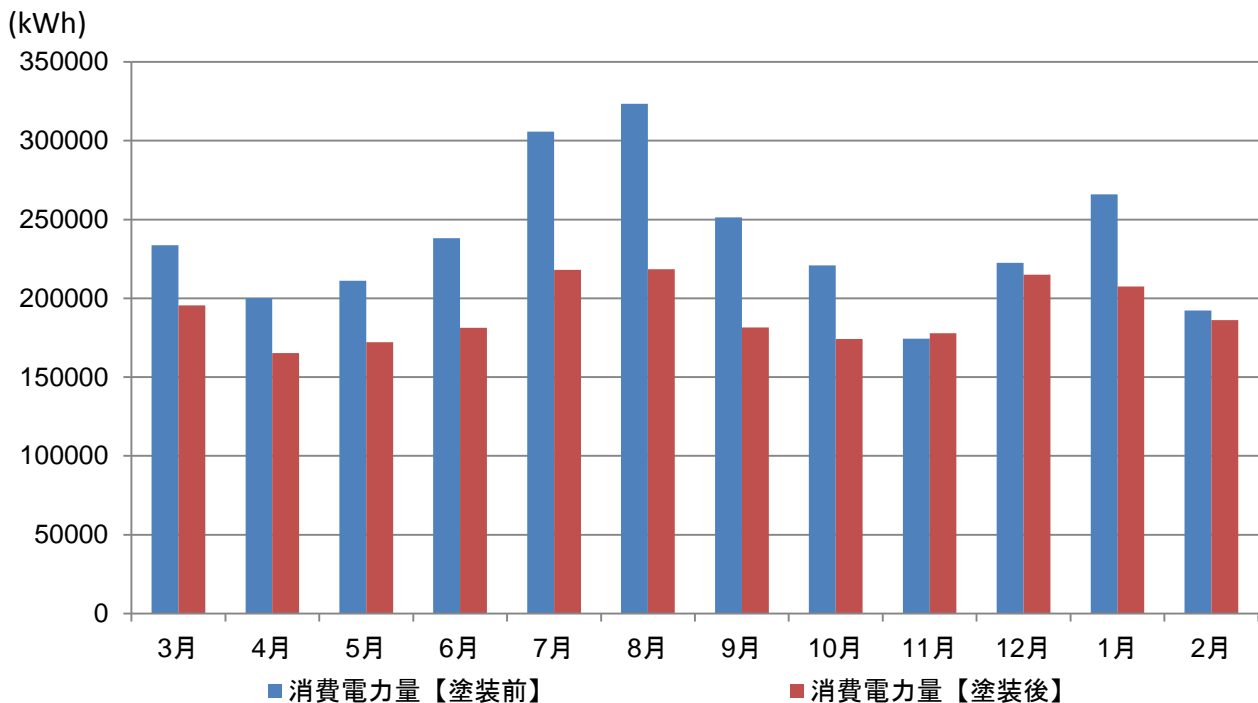
- 20% of energy saving in a year
- 7.1 million Yen was cut in a year (※13Yen/kWh conversion)

• Power consumption graph
